# Test Report

No. SDHL2003002353GA

Sample Description : MIRADOR IN 3X3.6M  
 Supplier Item No. : MI-3X3.6  
 Manufacturer : ZHEJIANG ZHENGTE CO., LTD  
 Supplier : ZHEJIANG ZHENGTE CO., LTD  
 Buyer : GALE  
 Country of Origin : CHINA  
 Country of Destination : AUSTRALIAN  
 Sample Receiving Date : Mar.16, 2020  
 Test Performing Date : Mar.17, 2020 to Mar.26, 2020

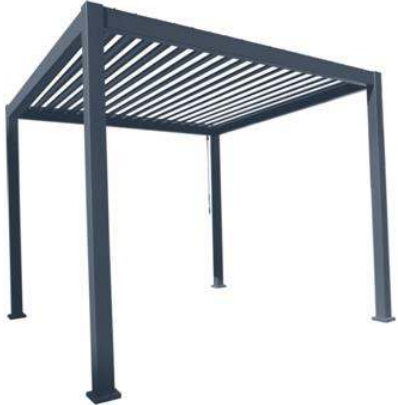
<p>Sample view</p>	<p>Photo of test</p>

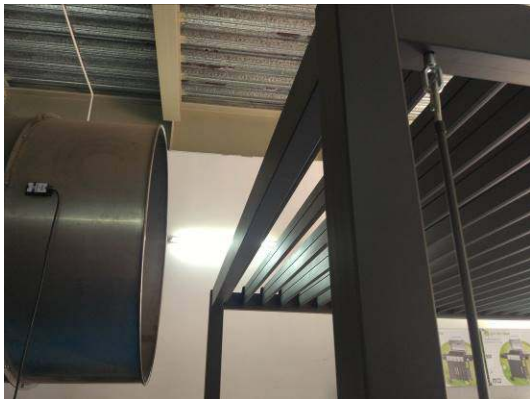
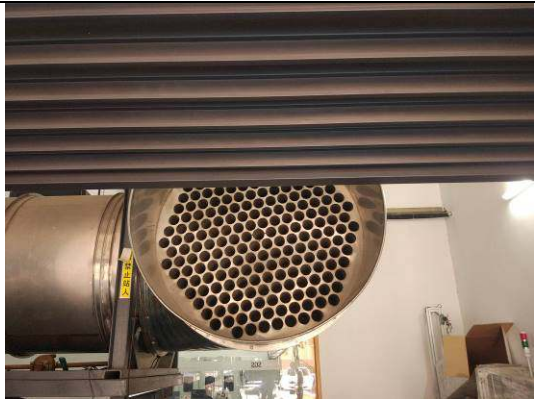
SGS In House Method		
Requirement	Remark	Verdict
<b>Wind resistance test</b>		
Install the pergola according to the manufacturer's instruction and make the center of side structure (top rail) to face the wind tunnel. Adjust the height of outlet of the wind tunnel if necessary. All the legs shall be secured to avoid moving during test. The pergola shall undergo total five times of wind resistance test, with using different ranks of wind speed (10m/s, 15m/s, 20m/s, 24m/s and 28m/s.) from low to high. The wind shall be applied to the center of the side structure (top rail) and shall keep a steady speed for 30 seconds in each rank of test. The pergola should be checked thoroughly after each time of test. The pergola shall have no damage or irreversible deformation after each rank of test. The test should be stopped when it becomes conscious of any damage or irreversible deformation.	See the Annex test table 1	Pass

Test wind speed	Wind scale	Verdict
10m/s	5	Pass
15 m/s	7	Pass
20 m/s	8	Pass
24 m/s	10	Pass
28 m/s	11	Pass

<p>/</p>
<p>Photo of test</p>	<p>/</p>
